NACA RM E57C12

ORIGIN AND DEVELOPMENT OF LEADING-EDGE CRACKS IN

TURBOJET ENGINE BUCKETS

By D. F. Springsteen, C. A. Gyorgak,  
and J. R. Johnston

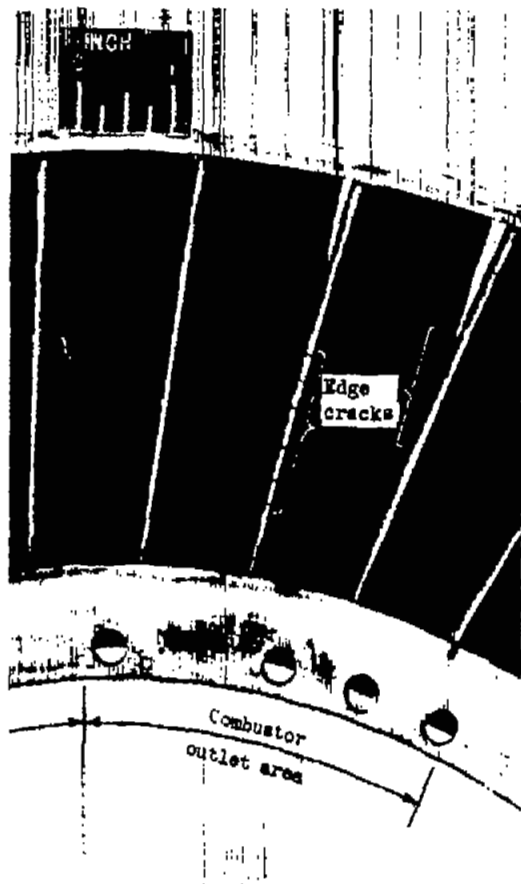
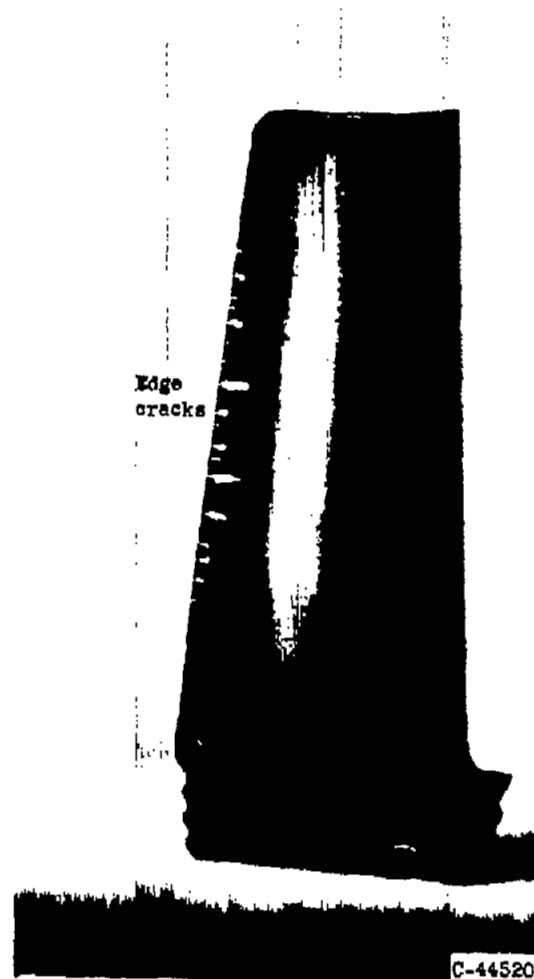
(a) Nozzle guide vanes.

(b) Turbine bucket.

Figure 1. - Edge cracks in nozzle guide vanes and a turbine bucket.

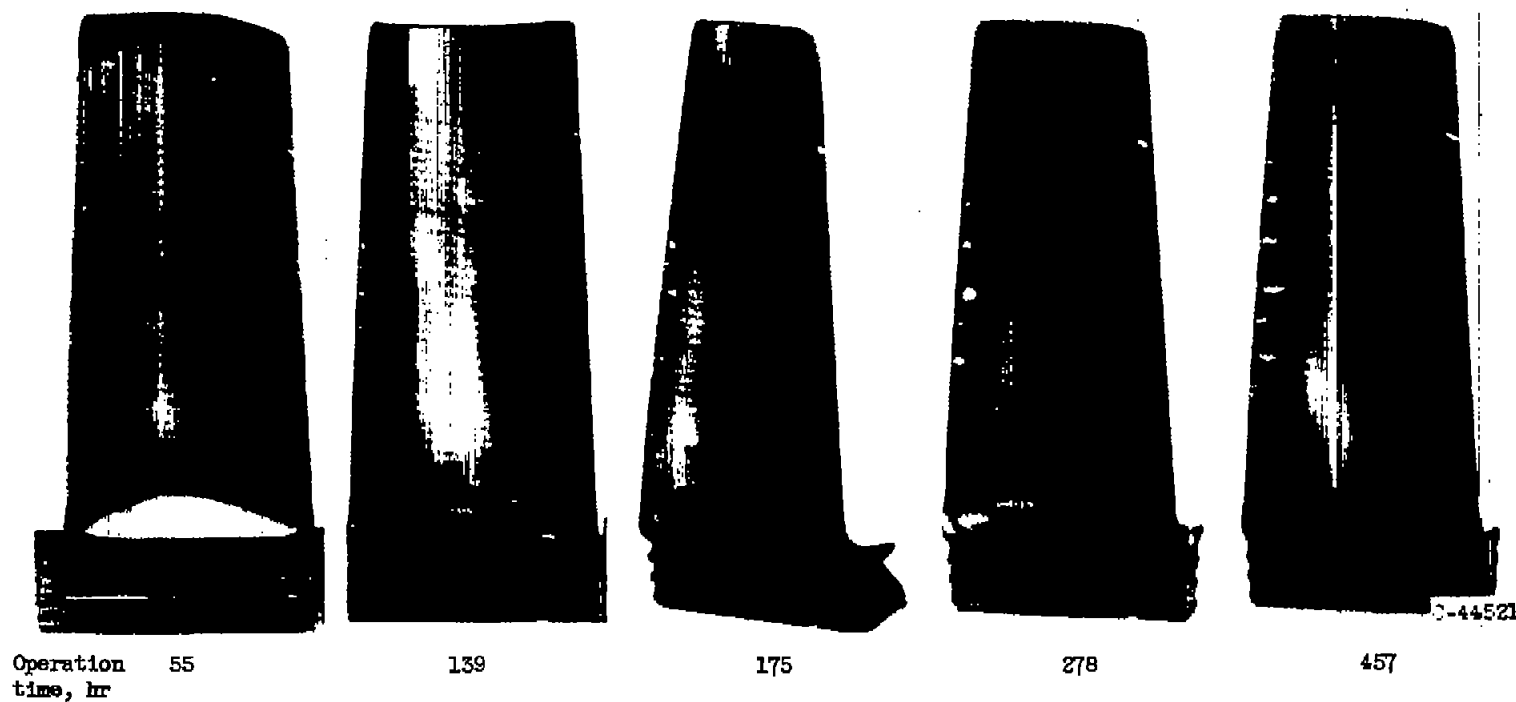
Two different types of crack propagation that occur in buckets are shown in figure 4. In the bucket shown in figure 4(a) (Inconel 550), the cracks were first detected during the 55-hour inspection. The cracks propagated at a moderate rate for the next 200 hours but then slowed to such a slow rate that the bucket was still operating when the test was discontinued after 500 hours. In contrast to the bucket shown in figure 4(a) is the bucket in figure 4(b) (S-816 bucket). This bucket developed only a few cracks by 55 hours. However, two of these cracks grew very quickly, and within 120 hours one of these two cracks was nearly  $1/2$  inch deep. For the next 125 hours the cracks hardly grew, until finally at 306 hours the bucket fractured.

Figure 4. - Examples of crack propagation in turbine buckets.

Figure 4. - Concluded. Examples of crack propagation in turbine bucket.

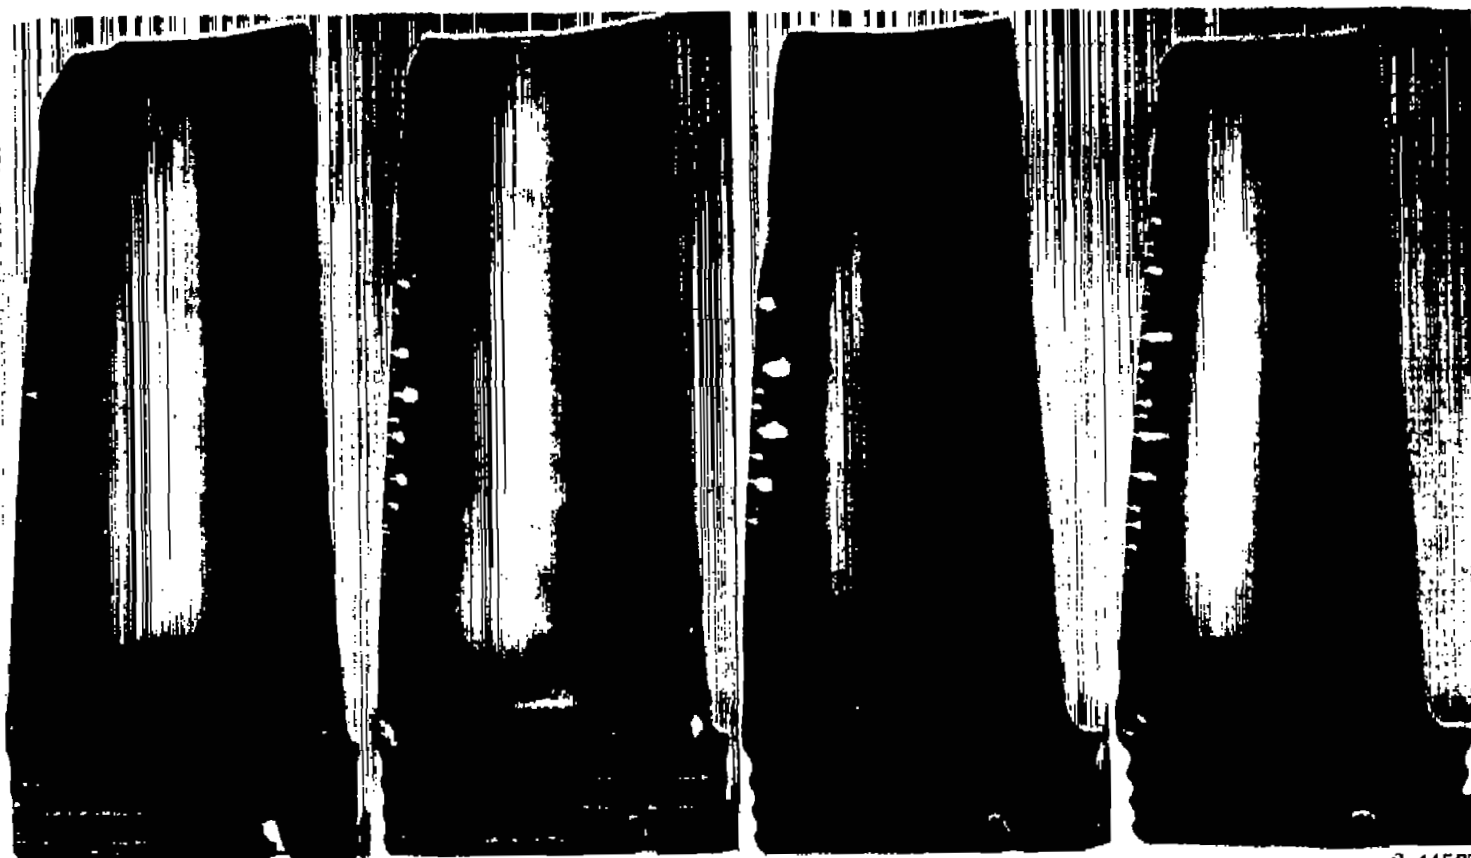
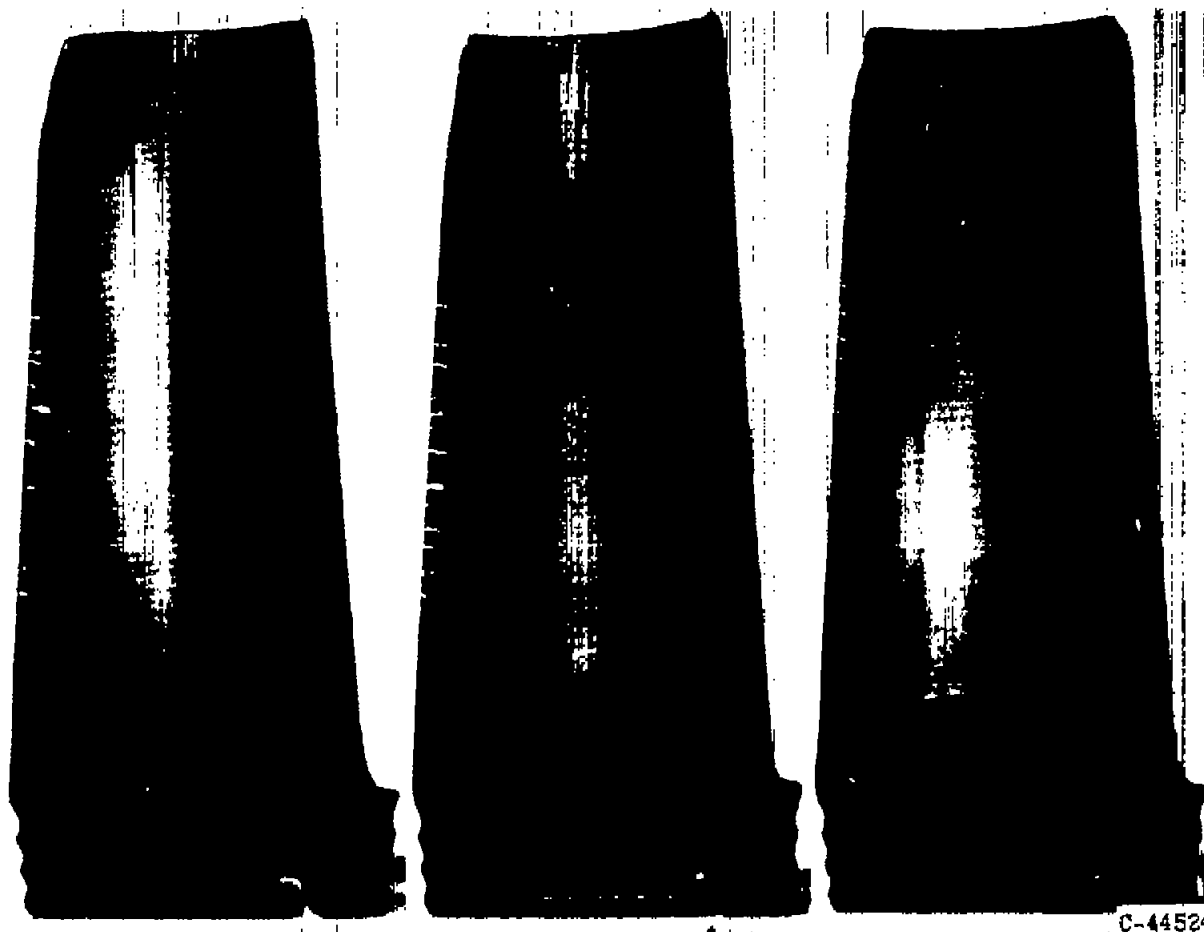
Fifty-nine of the buckets ran the full 500 hours without fracturing. Fifty-seven of these buckets had leading-edge cracks. (Two S-816 lot A buckets did not have cracks.) Figure 7 is a set of photographs taken after 500 hours of operation showing seven typical unfractured buckets with leading-edge cracks. Each bucket is a different as-received material. These photographs in figure 7 were taken with an ultraviolet light after the buckets were given a Zyglo treatment. During the  $1\frac{1}{2}$  hour exposure time, the Zyglo oil bled from the cracks, producing the blotchy effect seen in the photographs.

Figure 7. - Typical buckets that operated 500 hours at full power without fracturing. (Note leading-edge cracks.)

Figure 7. - Concluded. Typical buckets that operated 500 hours at full power without fracturing. (Note leading-edge cracks.)

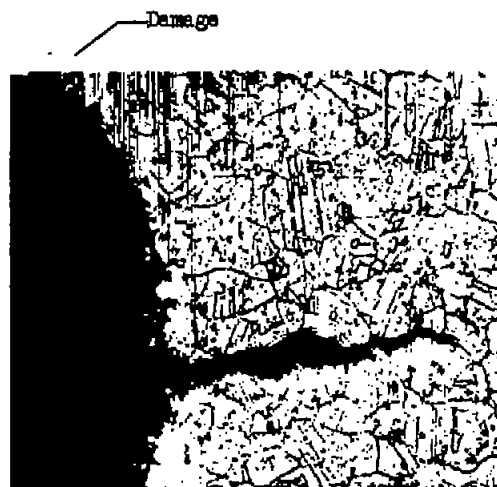
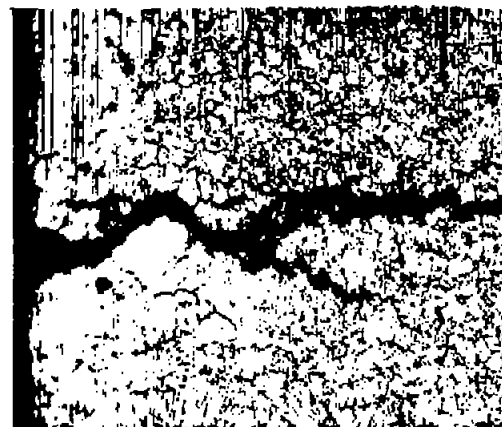
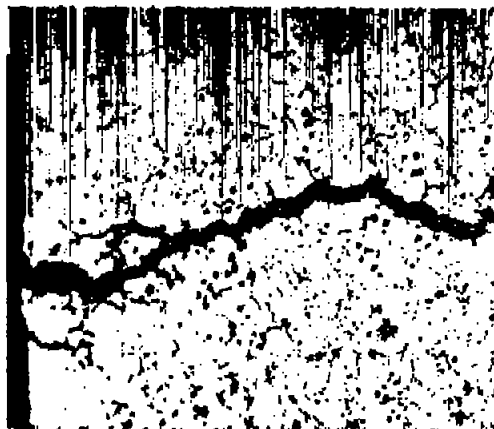
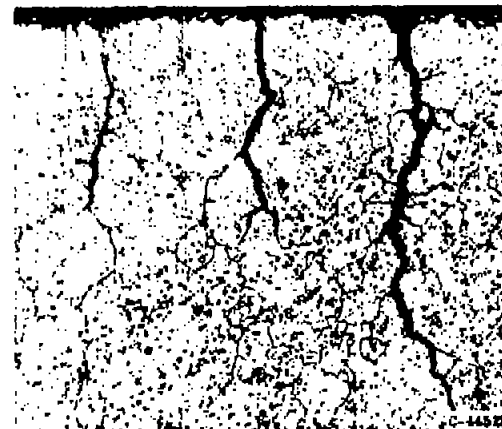
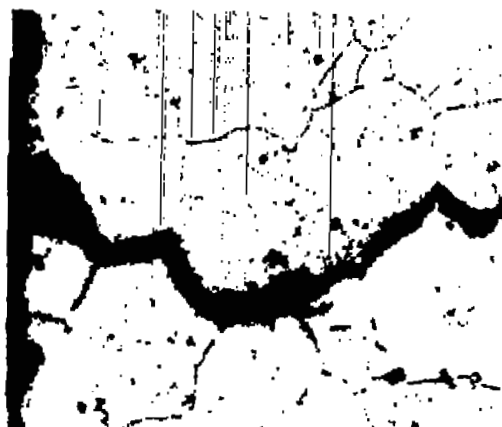
Microexaminations were performed on the leading-edge regions of the 29 buckets enumerated in table V to determine the nature of the leading-edge cracks. In almost every instance, the cracks appeared to be intergranular. Figure 8 shows photomicrographs of typical leading-edge cracks as they occurred in the unfractured buckets shown in figure 7. In all these photographs, the surrounding structures appear normal for the material.

Figure 8. - Microphotographs of loading-edge cracks in buckets operated 500 hours without fracture. Eight different lots of material. X400.

Figure 8. - Concluded. Microphotographs of leading-edge cracks in buckets operated 500 hours without fracture. Eight different lots of material. X400.

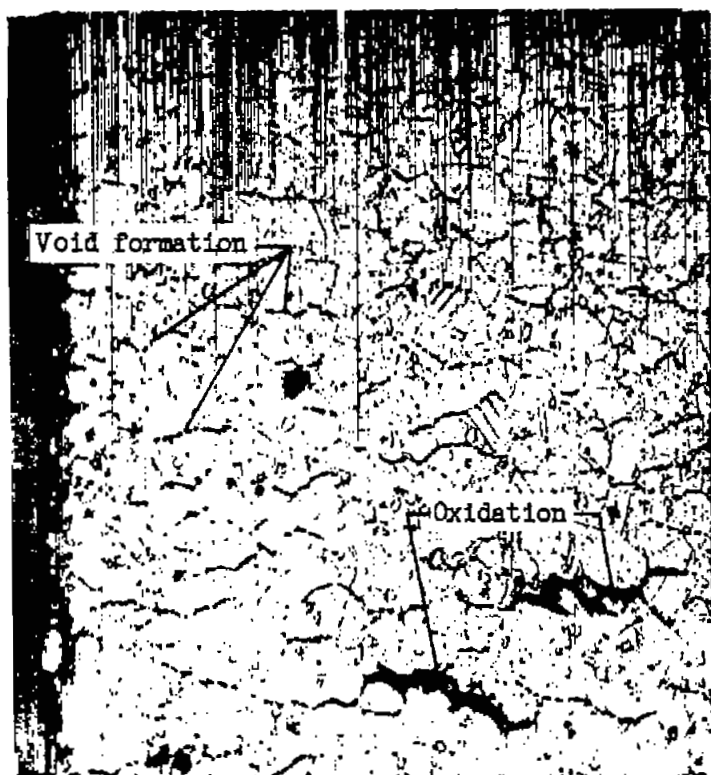
Of all the buckets examined, the only bucket with the slightest indication of abnormal structure was an S-816 lot B bucket (fig. 9). The small dark areas in the grain boundaries may have been caused by vacancy migrations. Some of the cracks that ultimately developed in the area were lined with oxides.

Metallographic evidence indicates that most of the cracks were intergranular and that oxidation was present along the interface of the cracks. There is no way of telling whether oxidation occurred before or after the cracks formed. In only one of the buckets examined (an S-816 bucket) was there an indication that intergranular oxidation may have taken place (fig. 9). There is a possibility that the unusual structure (the dark areas at the grain boundaries) surrounding the large oxidation concentrations shown in figure 9 may not be caused by oxidation, but rather

Figure 9. - Oxidation and void formation in grain boundaries of S-816 lot B bucket. X250.

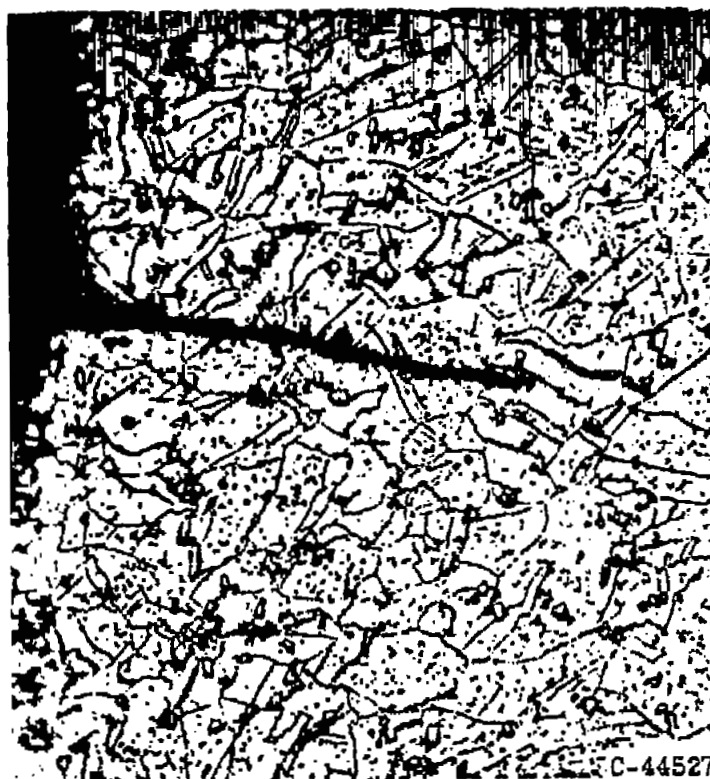
Figure 10 is a photograph of a leading-edge crack in an S-816 lot B bucket, which appears to be transgranular. This particular crack was the only definite transgranular leading-edge crack found during the microexaminations.

Figure 10. - Transgranular leading-edge crack in S-816 lot B bucket. X400.

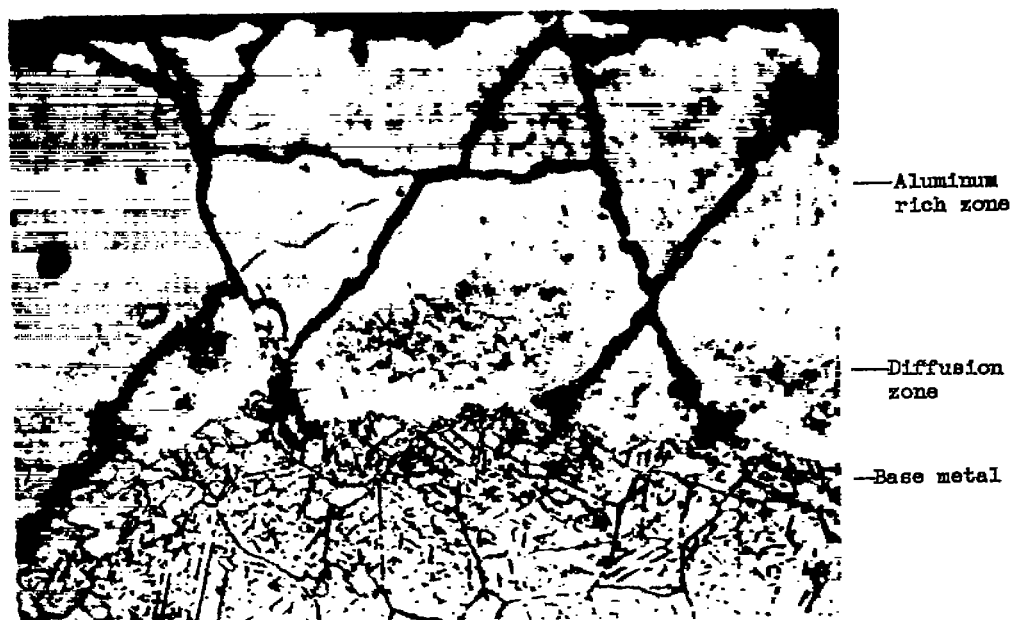
One of the aluminized S-816 buckets was removed from the wheel before it fractured (after 244 hr of operation), and a section was taken of the leading edge to determine whether the cracks penetrated beyond the aluminum coating. Figure 11(a) is a photomicrograph of the leading-edge region shown in figure 11(b). The photomicrograph shows diffusion has taken place between the aluminum coating and the base metal. The cracks did not extend beyond the diffusion zone (fig. 11(a)).

(a) Microphotograph. X750.

(b) 15X.

Figure 11. - Leading-edge cracks in aluminized S-816 lot A bucket.  
Operation time, 244 hours.

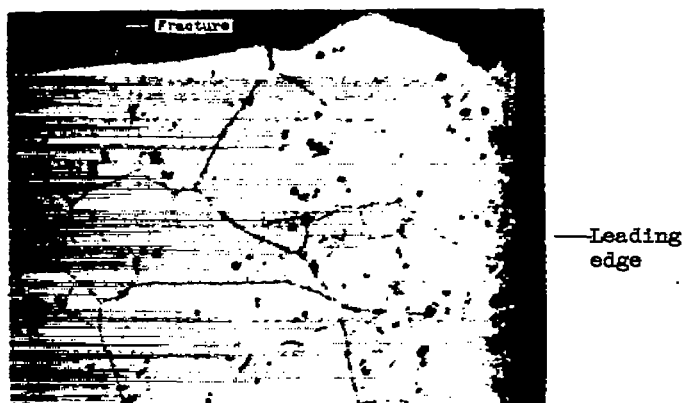
Figure 13. - Fracture origin in leading edge, Hastelloy R-235. Fractured, 312 hours.

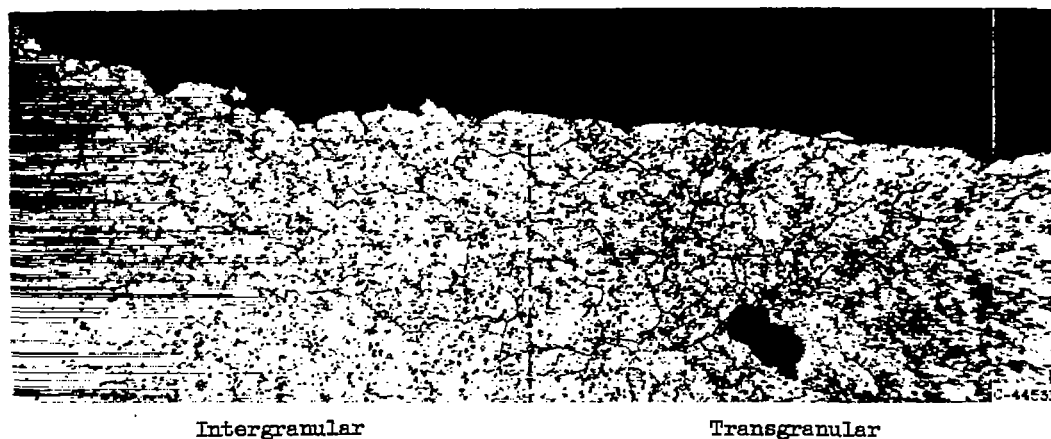
Microsections of 17 of the 35 fractured buckets were taken from the regions where the fractures occurred. Usually the region very close to the leading edge of the buckets appeared so oxidized that it was difficult to determine whether the fracture began as a transgranular or intergranular failure. In a few buckets, the region was not too badly damaged by oxidation, and the fracture origin appeared to be intergranular in nature. Figure 13 is a photomicrograph of the region where the fracture began in a Hastelloy R-235 bucket. The intergranular cracks in this Hastelloy R-235 bucket soon changed to transgranular and propagated as a transgranular crack for about 1/2 inch. Another example of a fracture changing from intergranular to transgranular, this time in an M-252 bucket, is shown in figure 14.

Figure 14. - Transition from intergranular to transgranular fracture for M-252.
